## Corrective Measures to Address Deficiencies Noted in the Coal Combustion Residuals Units Annual Inspection Report

## (Annual inspection covering the period from December 6, 2023 – December 3, 2024)

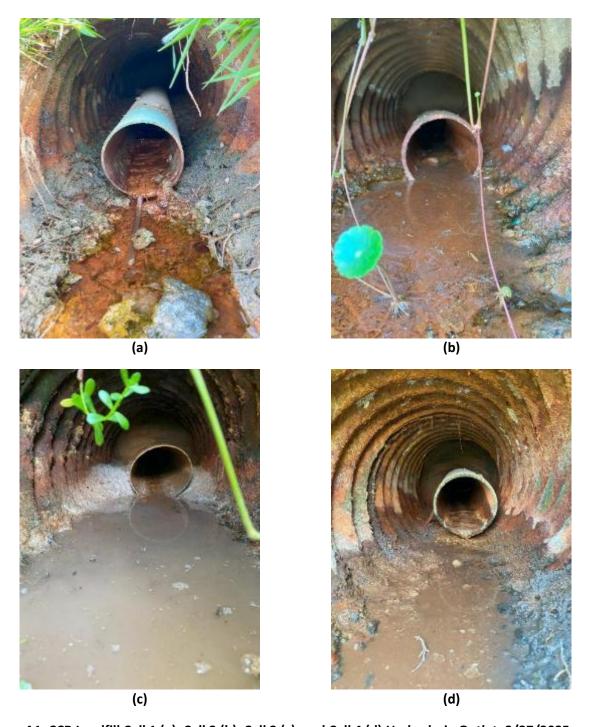
CCR Unit	Location	Previous Condition	Remedy Action	Attach.	Date of Remedy Completion
CCR Landfill	Northern Drainage Ditch	Underdrains were observed to be submerged or partially submerged underwater.	Water from the Northern Drainage Ditch was pumped to the onsite process ponds. Underdrains were above water level.	А	March 27, 2025
CCR Landfill	Landfill	Thick vegetation observed near the top of the slopes of Cells 1-3.	Outer slopes of landfill were mowed. ITS engineer inspected the vegetation on the landfill slope on May 6, 2025 and observed that the slopes are mowed.	-	April 7, 2025

Figure A1. CCR Landfill Cell 1 (a), Cell 2 (b), Cell 3 (c), and Cell 4 (d) Underdrain Outlet; 3/27/2025
