## **Corrective Measures to Address Deficiencies Noted in the Coal Combustion Residuals Units Annual Inspection Report**

**(Annual inspection covering the period from December 4, 2024 – December 3,  
2025)**

**Table 1. Remedies Taken to Address Deficiencies Noted in the 2025 CCR Units Annual Inspection Report**

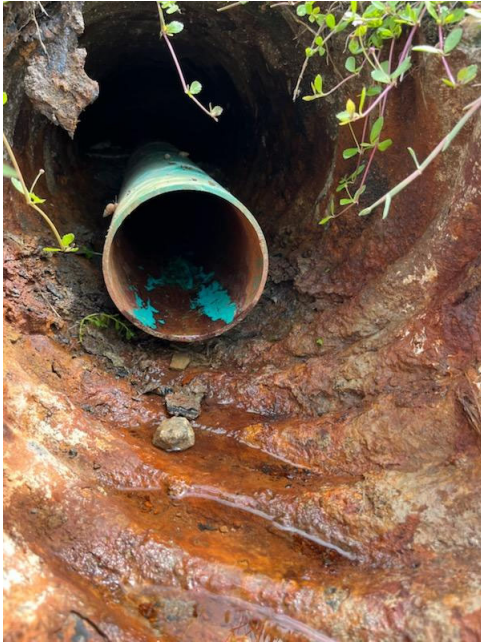
(a)

| CCR Unit | Location | Previous Condition | Remedy Action | Attach. | Date of Remedy Completion |
|---|---|---|---|---|---|
| CCR Landfill | Northern Drainage Ditch | Cell 1 underdrain was partially submerged due to elevated water levels in the Northern Drainage Ditch. All the underdrains exhibited some level of sediment accumulation. | Underdrains were jet cleaned to remove accumulated sediment. | A | June 16, 2026 |

**Figure A1. CCR Landfill Cell 1 (a), Cell 2 (b), Cell 3 (c), and Cell 4 (d) Underdrain Outlet; 6/16/2026. Photos were taken by GRU.**
