**PHASE I ENVIRONMENTAL SITE ASSESSMENT
GAINESVILLE RENEWABLE ENERGY CENTER
GAINESVILLE, ALACHUA COUNTY, FLORIDA**

**Gainesville
Renewable Energy Center
Gainesville, Florida**

**101084-0700
MARCH 2014**

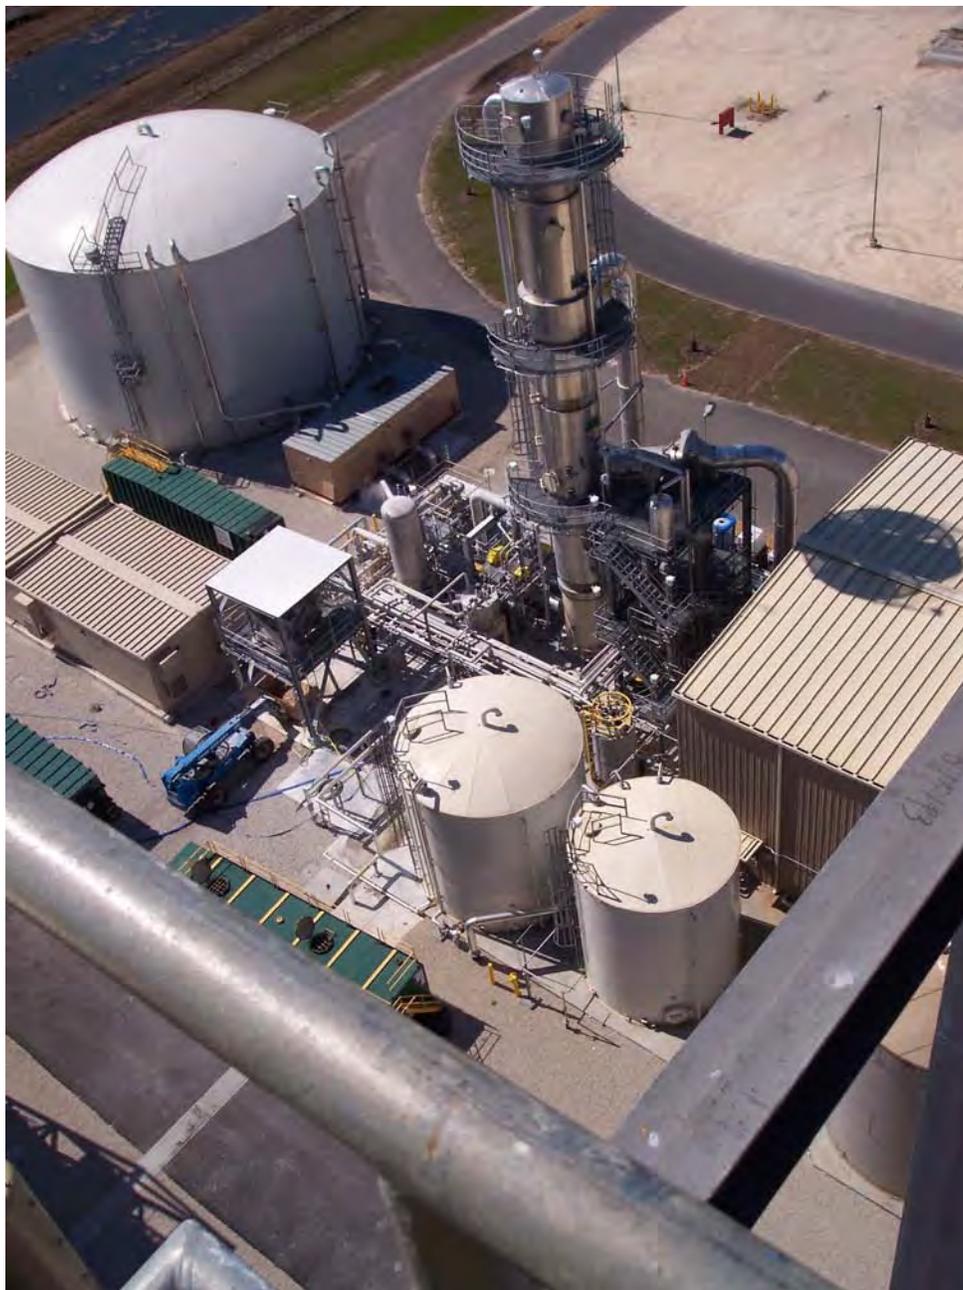
Photograph #3: Aerial view of the aboveground storage tanks associated with The zero liquid discharge system.

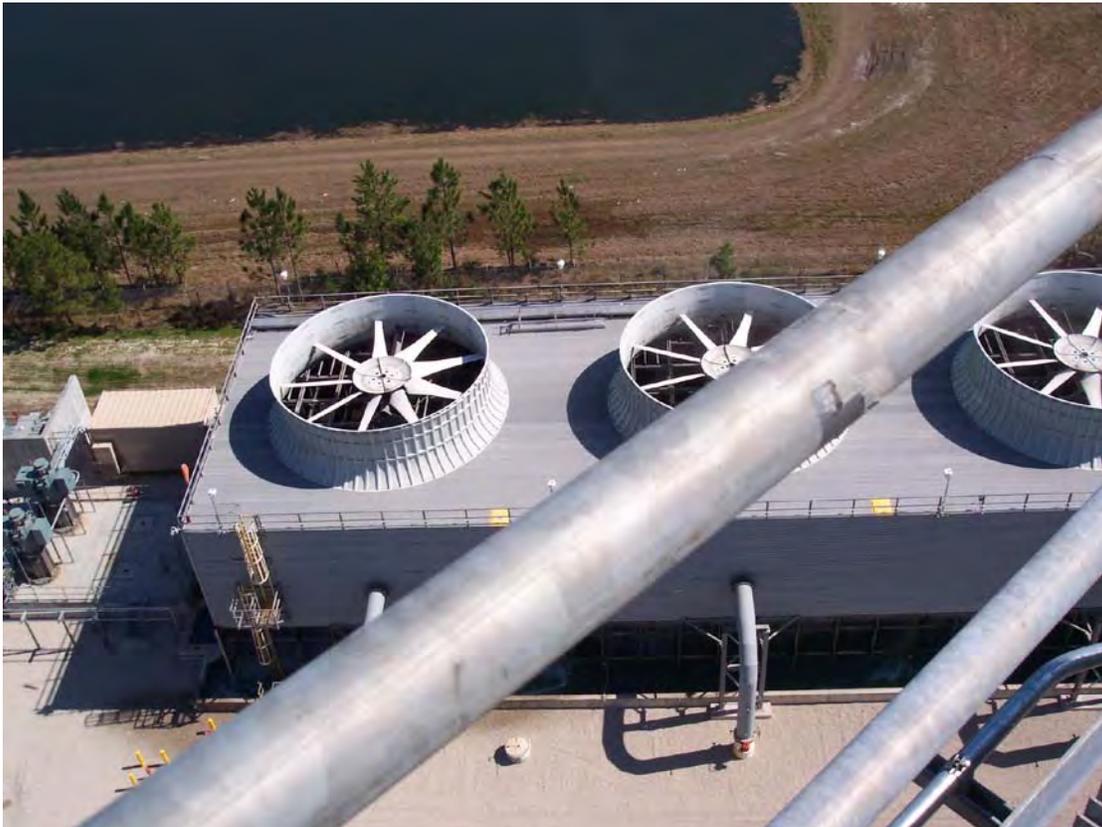
Photograph #4: Aerial view of the cooling tower.

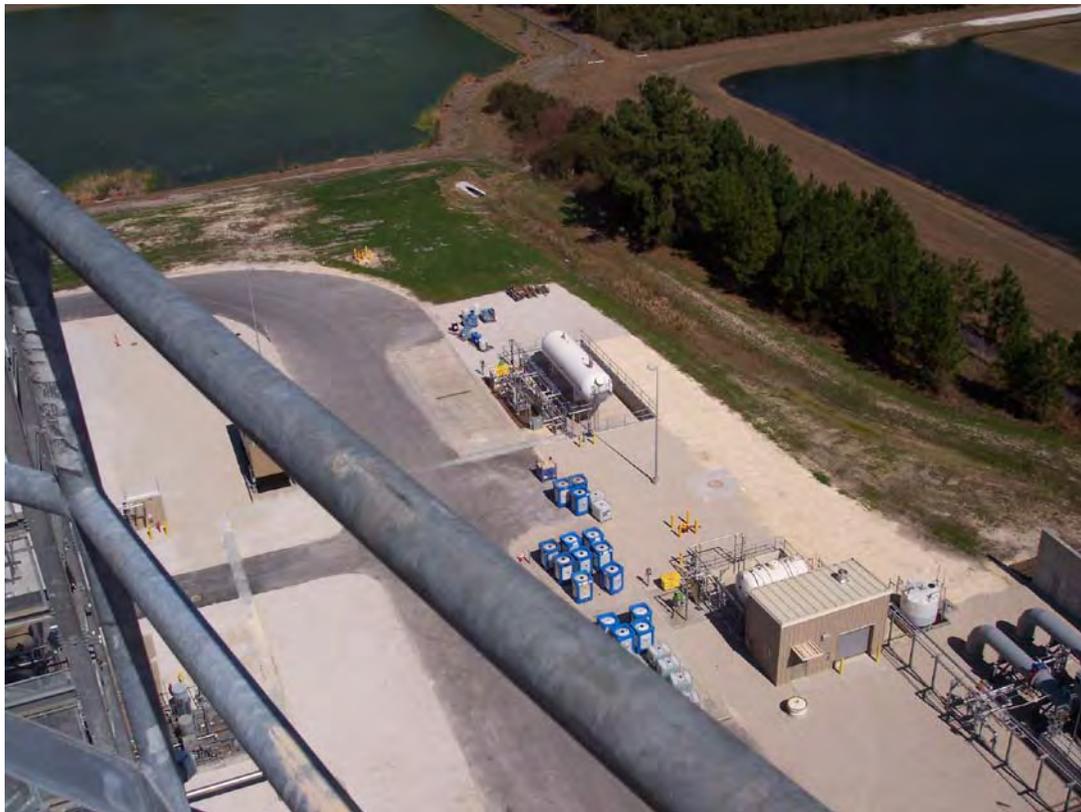
fuel fueling “wagon” located in the wood yard used to fuel plant equipment. There is a 5,200-gallon sulfuric acid storage tank in secondary containment located north of the cooling tower. There is a 15,000-gallon aqueous ammonia tank within secondary containment located north of the cooling tower. Other ASTs include raw water / fire water tanks, reclaimed water tank, a condensate tank, demineralized water tank, sodium hypochlorite tank, coagulant tanks, and other tankage associated with process/potable water treatment and the zero-liquid discharge system. All ASTs holding hazardous chemicals are stored within secondary containment.

Photograph #5: Aerial view of the AST, chemical and tote storage. Note secondary containment.

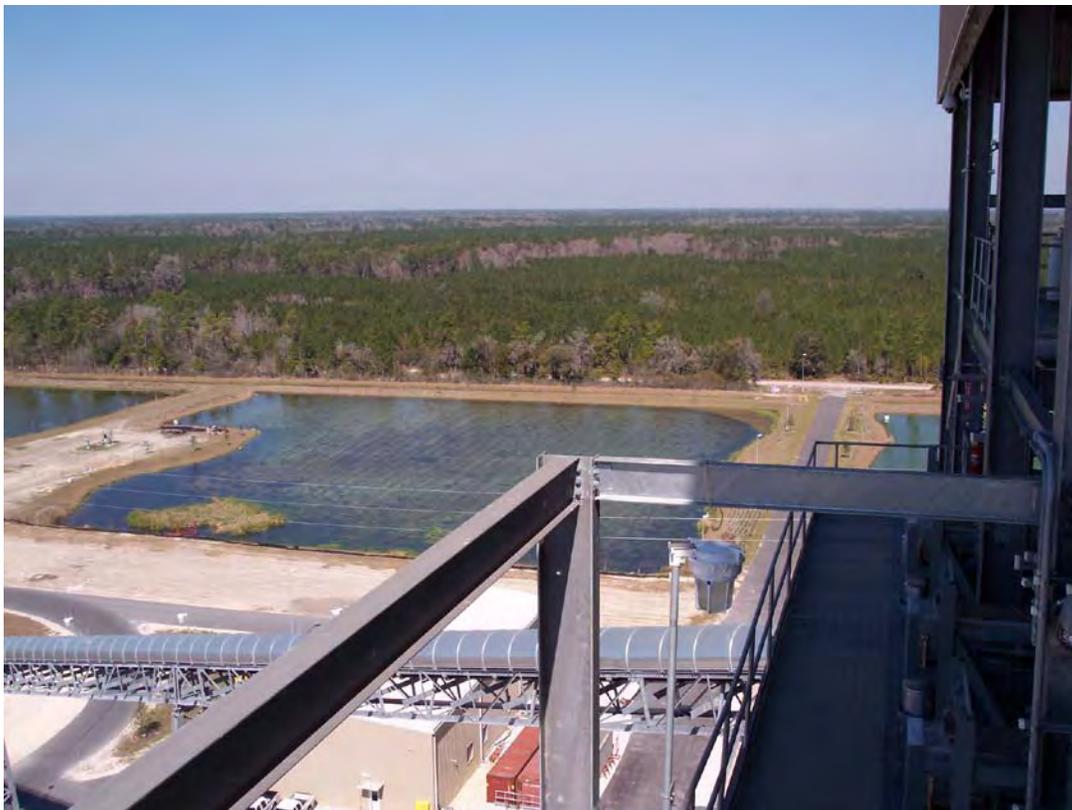
Five stormwater ponds were observed on the subject property. Three ponds are located along the northern boundary of the subject property, one is located across the road from the truck dumpers and one is located east of the entrance road. No sheens or odors were apparent on any of the surfaces of the water bodies. Stormwater retention ponds and process water ponds are located on the eastern adjacent property.

Photograph #7: Aerial view of the central-northern retention pond looking north to adjacent undeveloped land.

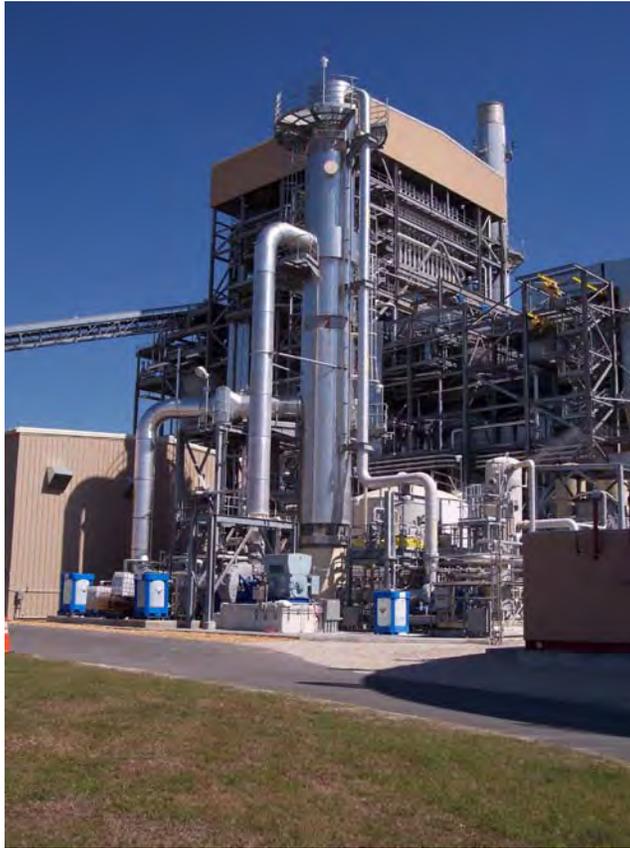
Photograph #8: View of the zero liquid discharge system and the steam Boiler in the background

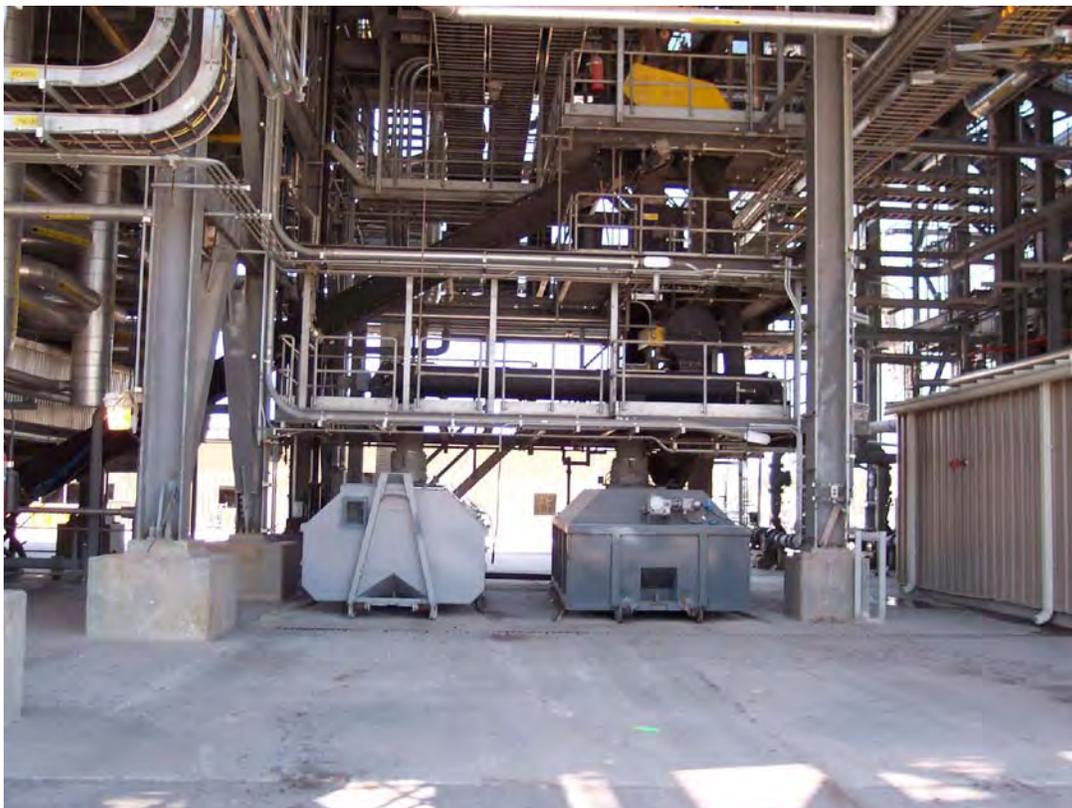
Two dumpsters were observed across the parking lot from the office/control room building for conventional solid waste. Two dumpsters were observed under the boiler to receive bottom ash and a dumpster is provided to receive solids from the zero-liquid

Photograph #9: View of dumpsters associated with the boiler bottom ash.

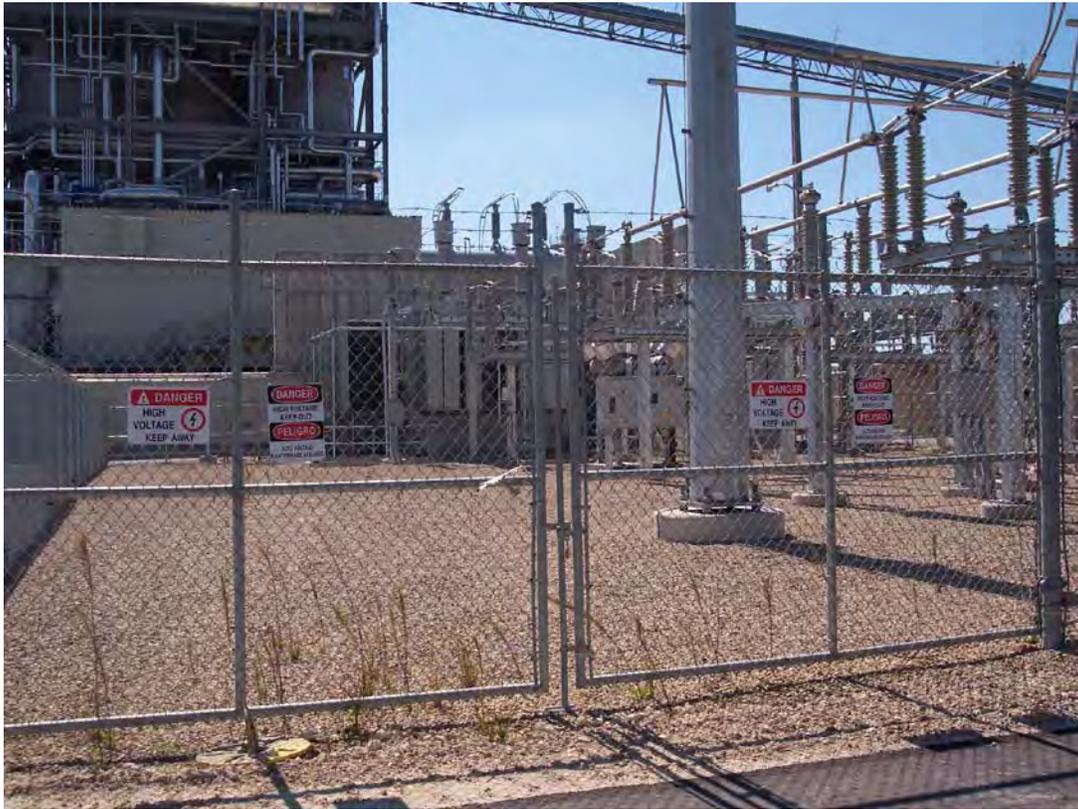
Numerous transformers were observed throughout the power block and throughout the plant site. The transformers and the equipment in the switchyard do not contain PCBs, according to the site contact.

Photograph #10: View of the switchyard.

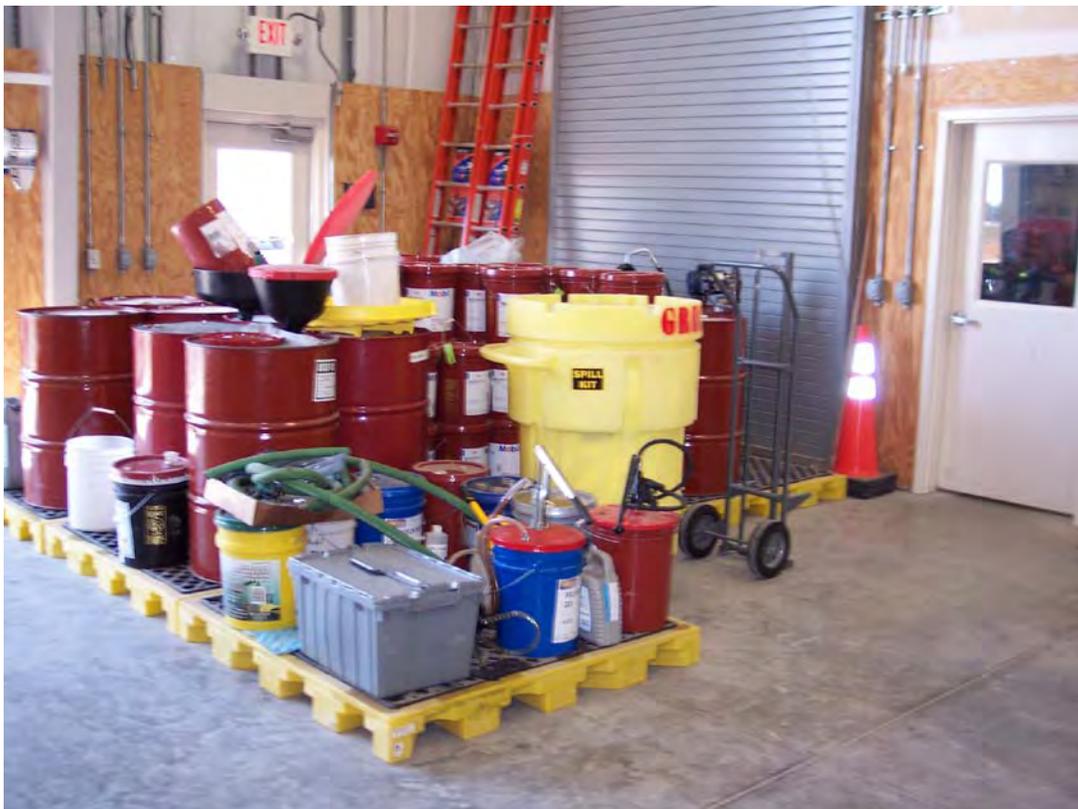
Many totes and drums of water treatment chemical products were observed in a secondary containment structure located north of the cooling tower. No spillage was observed on the concrete base of the containment area. Various chemicals are in use at the zero liquid discharge treatment area and at the cooling tower. These in-use chemicals are stored within secondary containment. A sulfuric acid tank and an aqueous ammonium hydroxide tank are within secondary containment as well as unloading containment; no evidence of releases or spillage was evident. A double-walled fuel tank is provided for the standby diesel generator. No evidence of the spillage of fuel was noted. A portable 500-gallon fuel "wagon" is provided to fuel the fuel yard vehicles, gators and other service vehicles. This mobile fueling unit is double-walled to provide tank containment and appears to be in good operating condition. No evidence of any releases was noted. Bulk soda ash is stored in an onsite storage silo. The silo receives product from trucks specifically designed to transport and transfer the specific product. Small quantities of reagent chemicals were noted for laboratory use.

Photograph #11: View of an area of chemical storage. Note secondary containment.

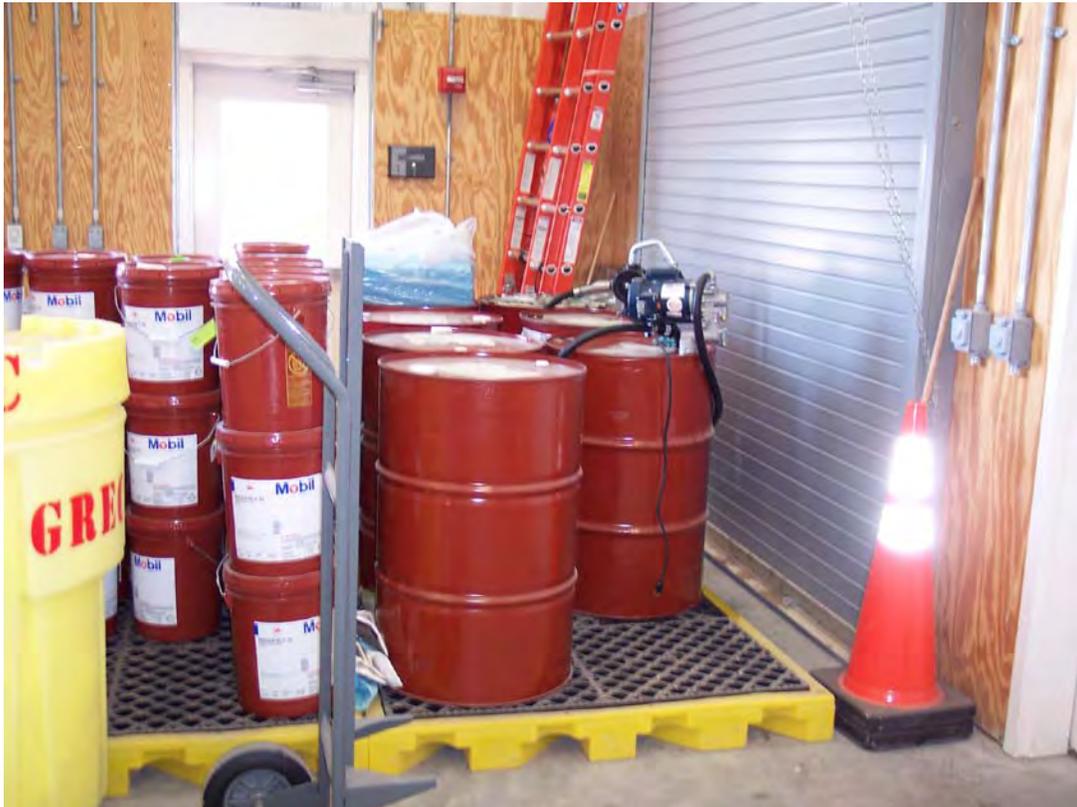
Many drums and totes of new and in-use product were observed in the zero-liquid discharge process area at the cooling tower and at the receiving pad containment north of the cooling tower. These drums and totes were observed to be stored in secondary containment.

Photograph #12: View of an area of chemical storage. Note secondary containment.

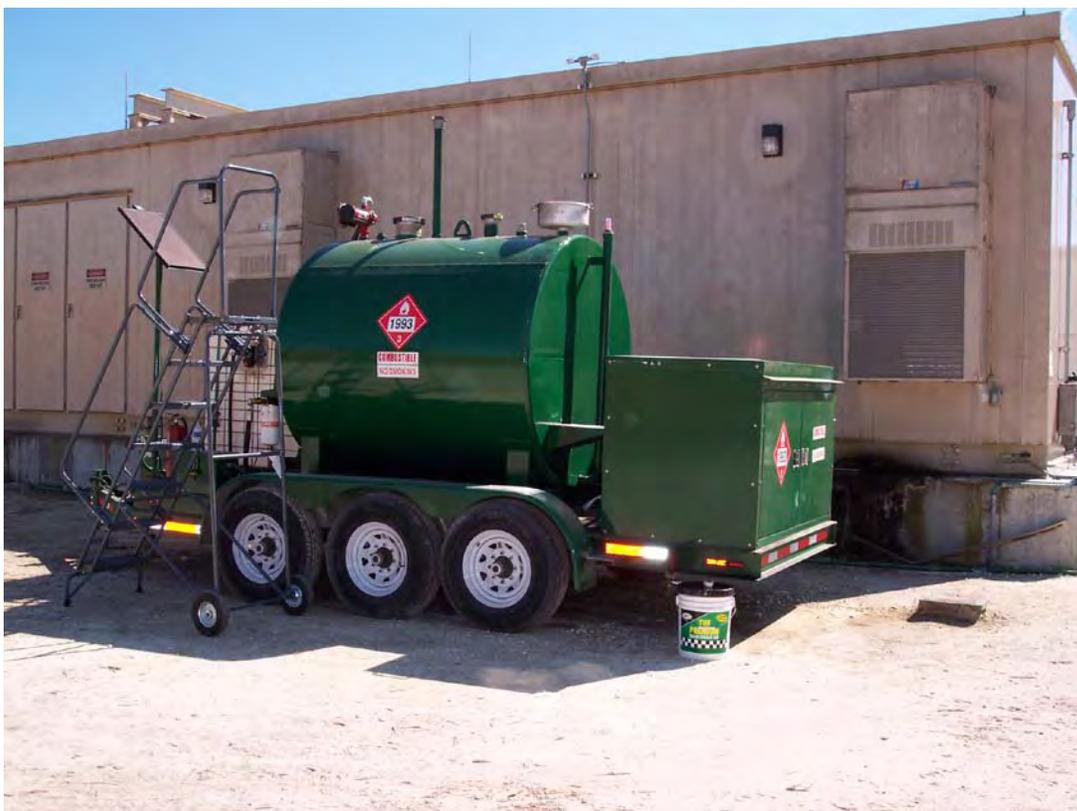
Photograph #13: View of the mobile diesel fuel aboveground storage tank.

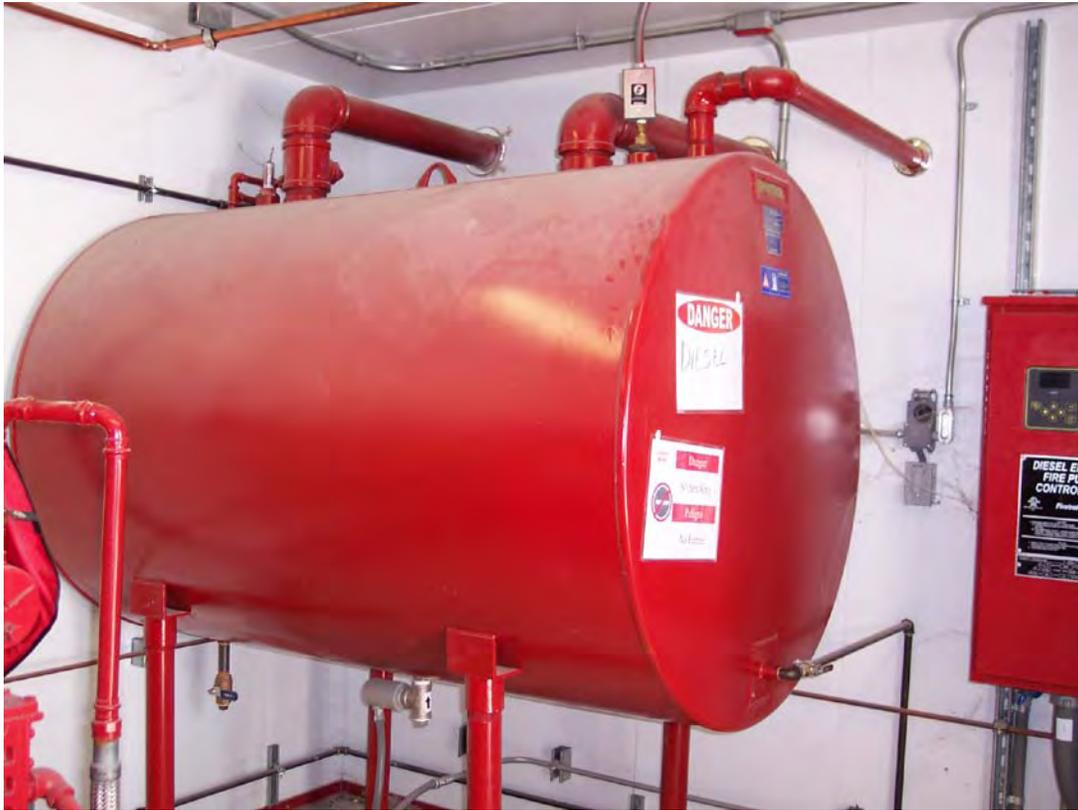
Photograph #14: View of the diesel fuel aboveground storage tank associated with the fire pump.

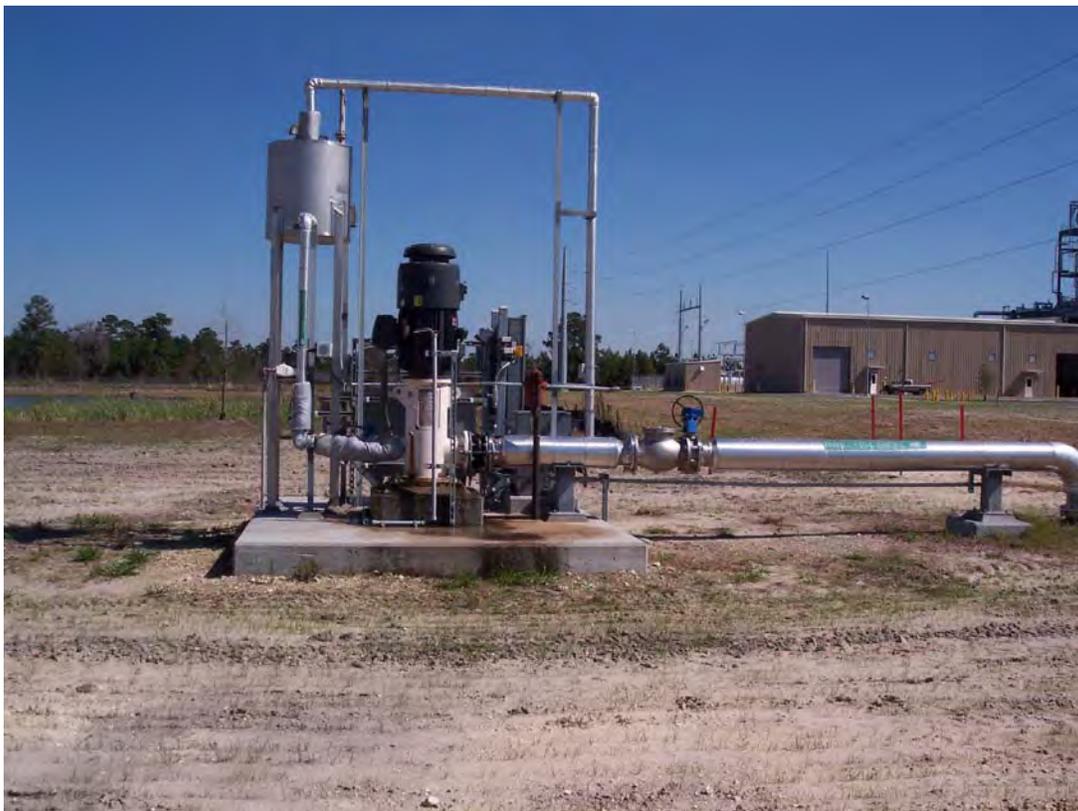
Photograph #15: View of one of the two process water wells.

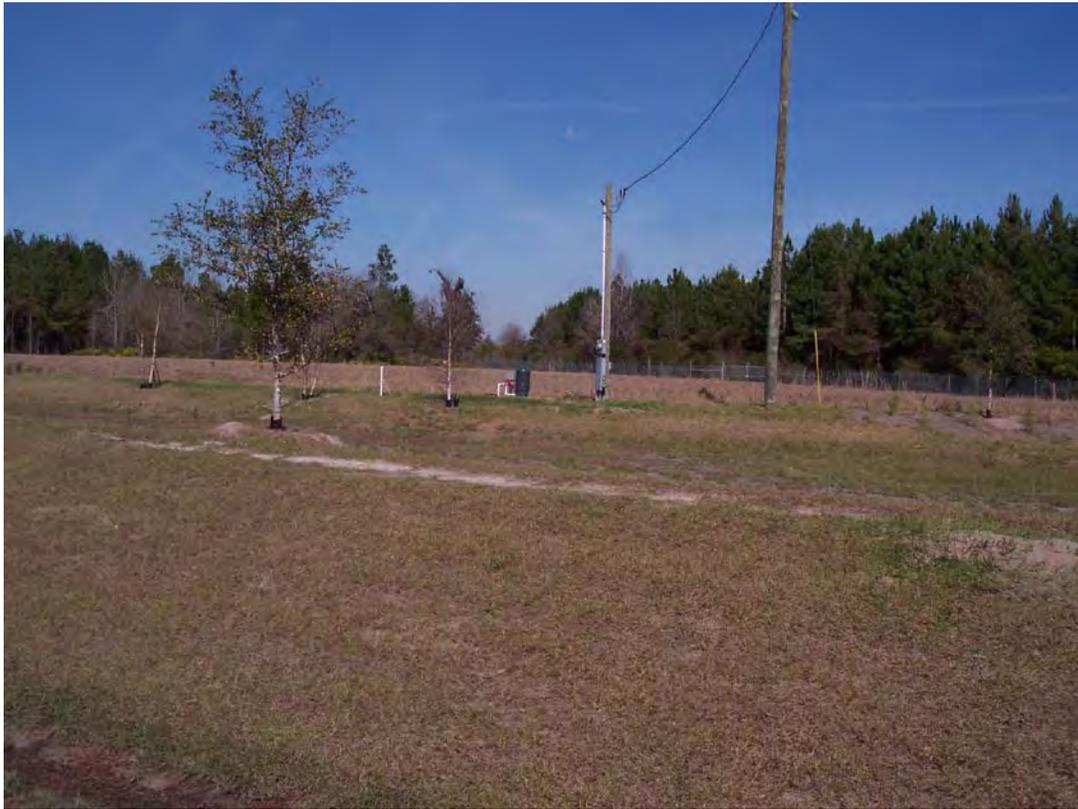
Photograph #16: View of a temporary irrigation well.

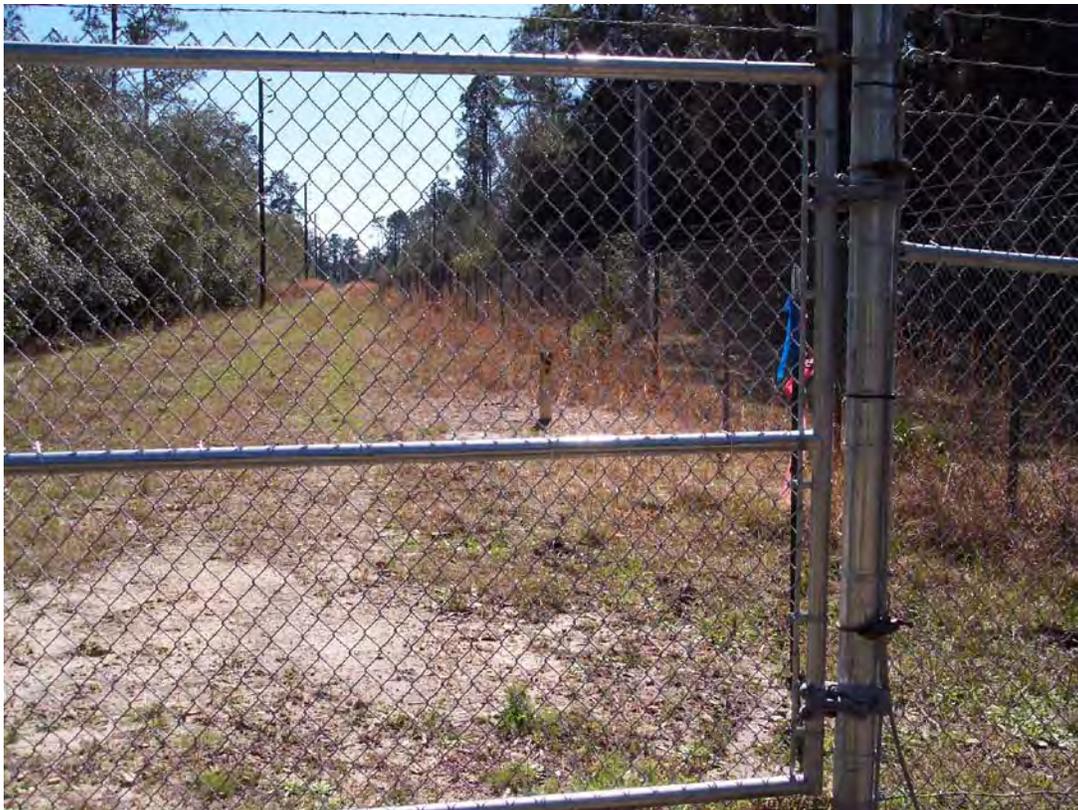
Three monitoring wells were observed along the western property boundary, one monitoring well was observed along the eastern boundary, and one monitoring well was observed near the northeastern corner of the subject site. Two production wells are located onsite as is a potable water well. There are two temporary irrigation wells.

Photograph #17: View to the south along the western property boundary of one of the Deerhaven Generating Station perimeter monitoring wells.

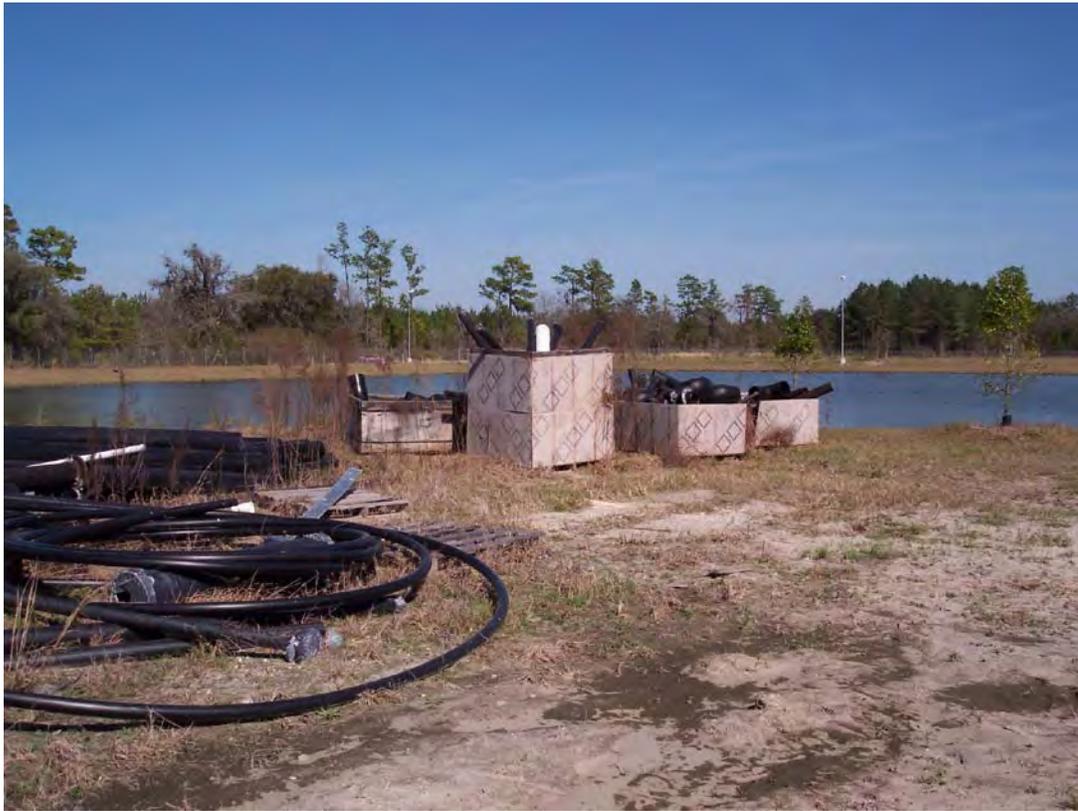
Photograph #20: View of (PVC) equipment and parts stored outside in the northern portion of the subject site.

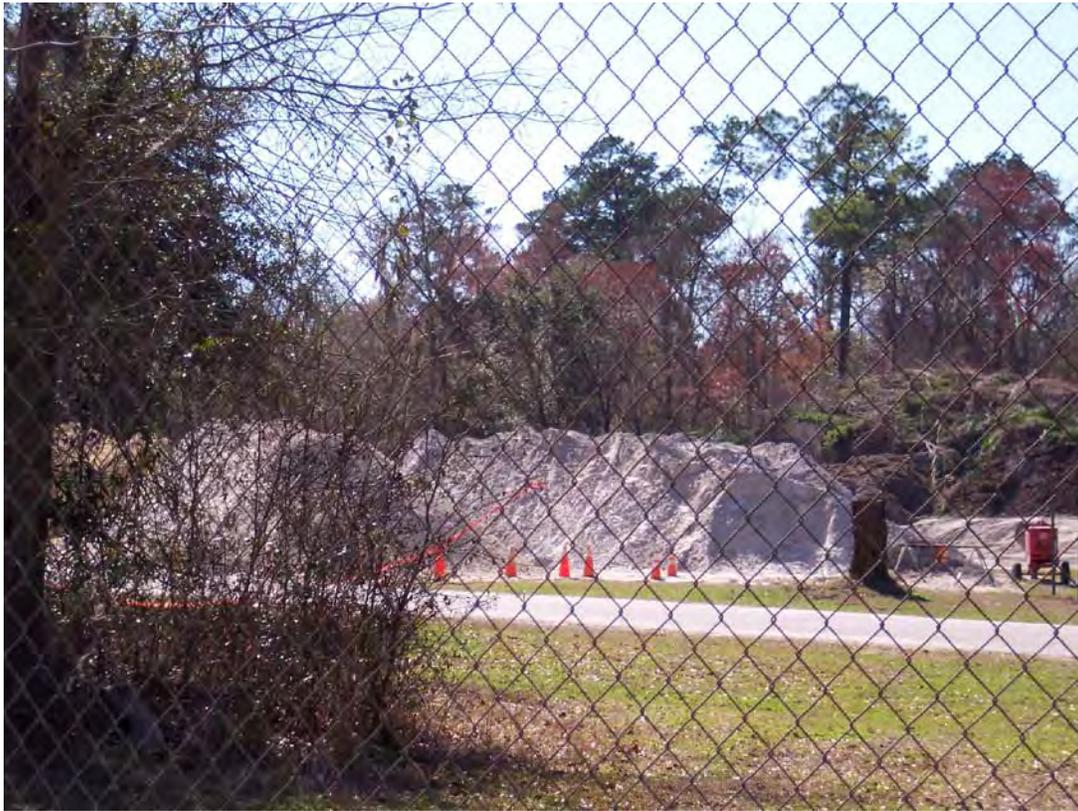
Photograph #24: View of stockpiled material on the western adjacent property associated with the Alachua County Public Works facility.
